**Chris Breeding**

## MANUAL SYSTEM

## AUTOMATED SYSTEM

### Background information

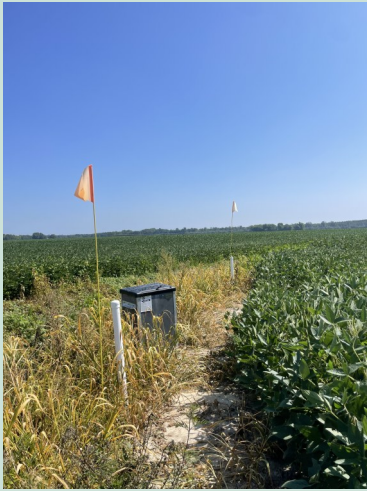
- Installation date: February 2023
- Acres managed: 37.7 acres
- Water control structure size: 12 inches

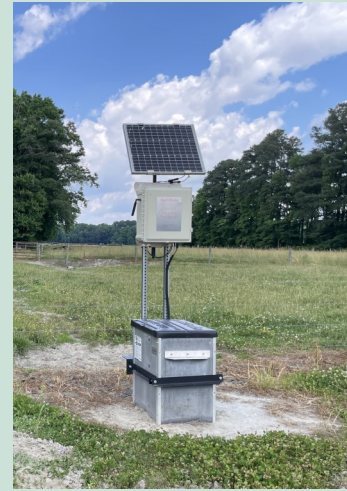
- Installation date: December 2021
- Acres managed: 38.8 acres
- Water control structure size: 12 inches

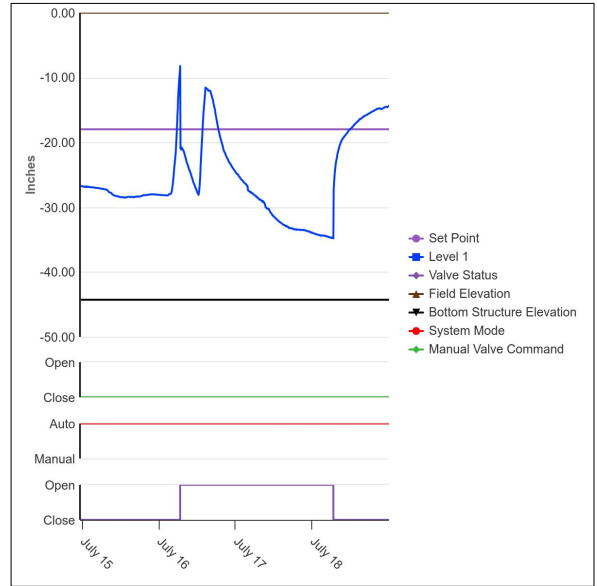
Figure 1. Close-up of the automated structure adjusting the water level to the mid-July rainfall event.

The site received a total of 95.8 inches of precipitation during the study period, including a significant storm in mid-July that brought 7.51 inches of rain (Figure 2). In response, the automated structure was adjusted to lower the water level in the field (Figure 1). Meanwhile, the manual structure remained without boards to help manage in-field water, resulting in maximum recorded flow. Overall, the manual structure experienced higher flow due to less intensive board management, with an average flow rate of 95.2 gallons per minute (gpm), compared to 21.5 gpm for the automated structure.

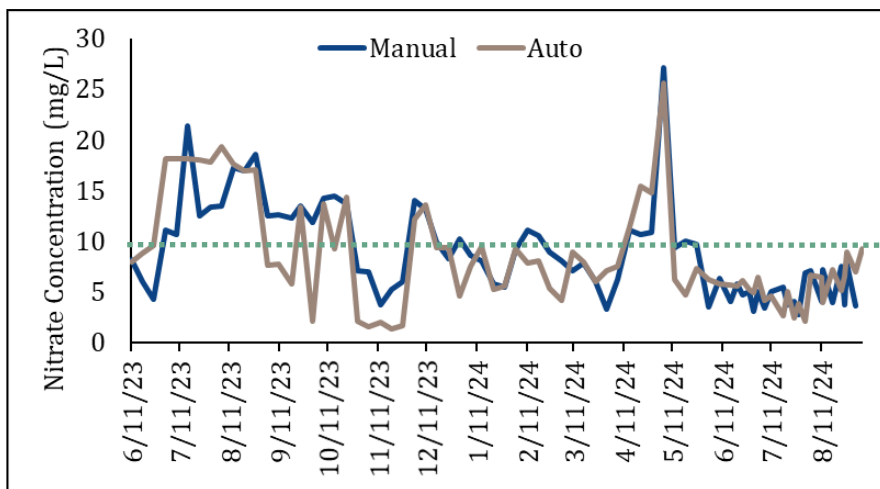
Figure 3. Nitrate concentrations for both structures. The EPA limit of 10 mg/L for drinking water is represented with a green dotted line.

The nitrate ( $\text{NO}_3$ ) concentrations in the tile drainage water from both systems (~8 mg/L) fell within the typical range for agricultural fields (6–16 mg/L). Observed concentrations ranged from a minimum of 1 mg/L to a maximum of 27 mg/L (Figure 3). The flow-weighted  $\text{NO}_3$ -N concentrations were 10.4 mg/L and 7.8 mg/L for the manual and automated structures, respectively.

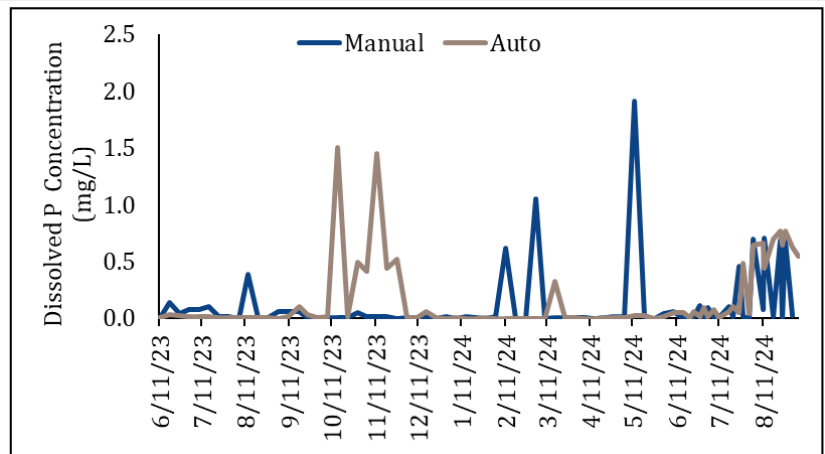
Figure 6. Dissolved phosphorus concentrations for both structures.

The average flow-weighted dissolved phosphorus concentrations for the manual and automated systems were 0.005 and 0.05 mg PO<sub>4</sub>/L, respectively (Figure 6). Although slightly higher than the EPA dissolved phosphorus limit of 0.02 mg P/L to avoid eutrophication, these concentrations were lower than the average of 0.012-0.253 from other tile drainage studies across the US. The minimum concentrations were 0 mg/L, while the maximum concentrations were 2.4 mg/L.

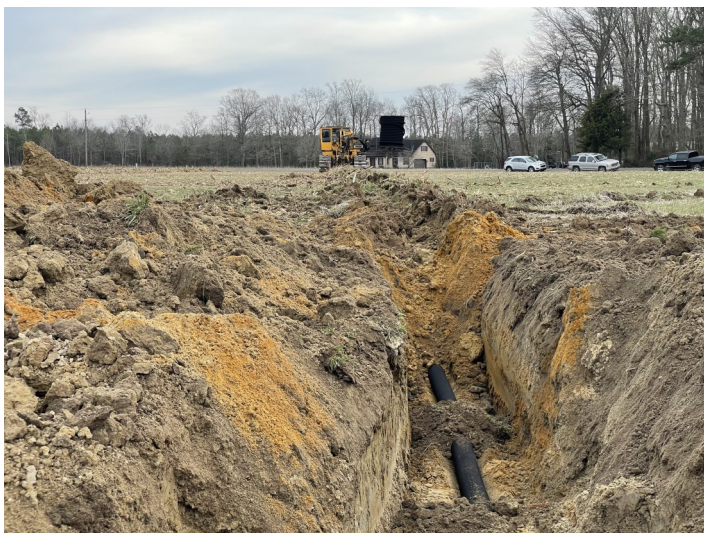
Tile installation at manual drainage water management system in February 2023.
