LAST RESORT FARM NOT STALLED BY DAIRY BARN CONVERSION FOR PRODUCE

ABOUT THE PROJECT

Overview: Renovation of an existing dairy barn. Turning an area of 23'x68ft (1,950 sq. ft) into washing, packing and storage space.

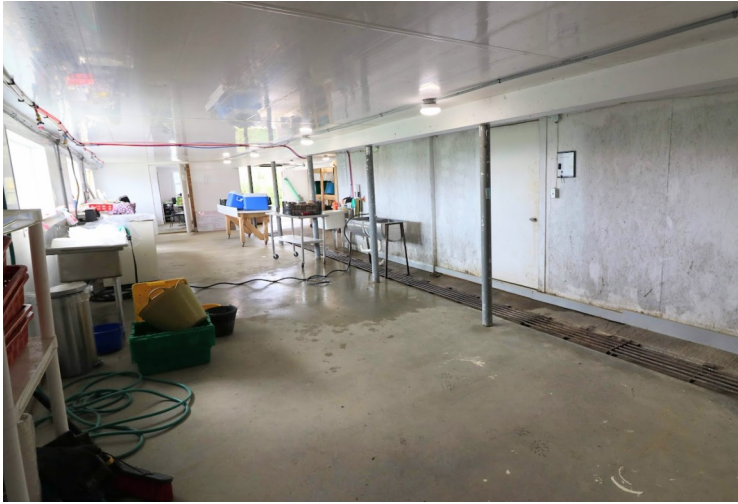
▲ Ceilings are finished with [Trusscore](#), covering up existing flaking paint and enclosing new insulation. Cooler walls painted white, large south facing windows, and an “open” floor plan makes for a bright and useful working environment.

Another key feature was cleanability. Installing smooth cleanable surfaces allows the space to be cleaned well on a regular basis. He used [Trusscore](#) as a finish material on inside walls. This is easy to install and doesn't require any sheathing behind it. It’s not cheap but Silas worked the numbers and noted, “Based on labor savings it seemed to come up on top.”

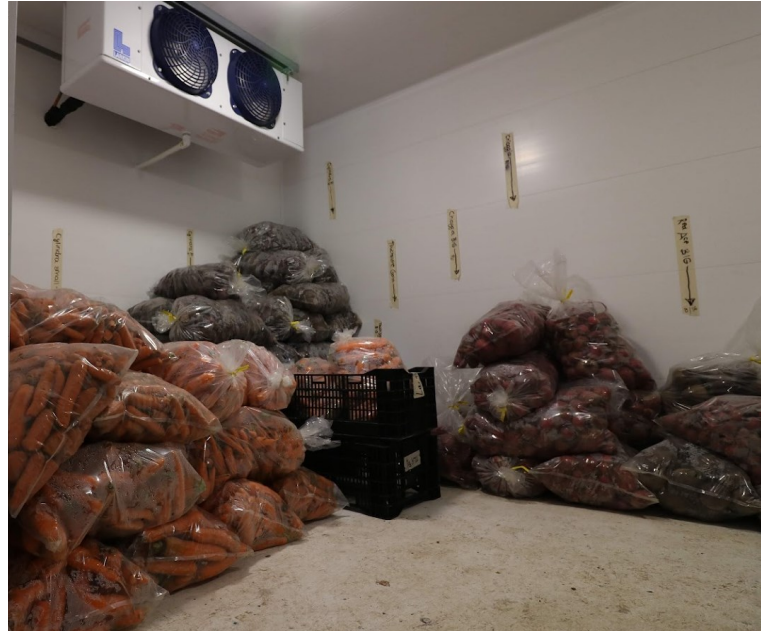
▲ This cooler is equipped with a commercial split refrigeration system and used when there needs to be a lot of field heat removed quickly. Shelves are planned, but temporary organization is accomplished with masking tape.

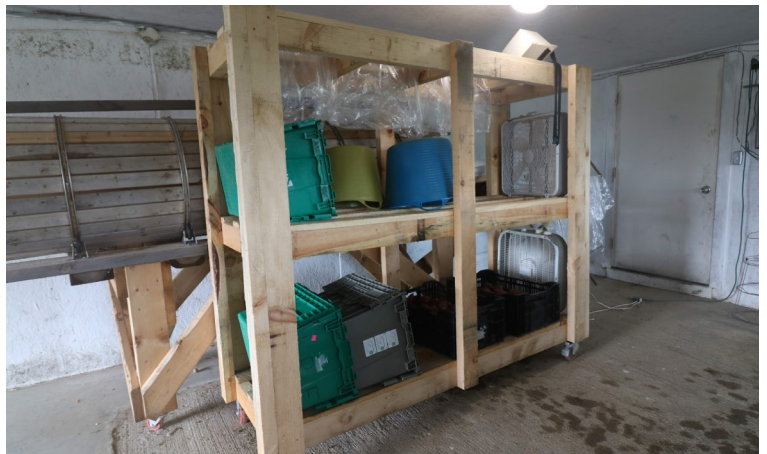
▲ A custom DIY rack for drying and storing totes. Both the rack and the barrel washer on wheels for flexibility and easy mobility.

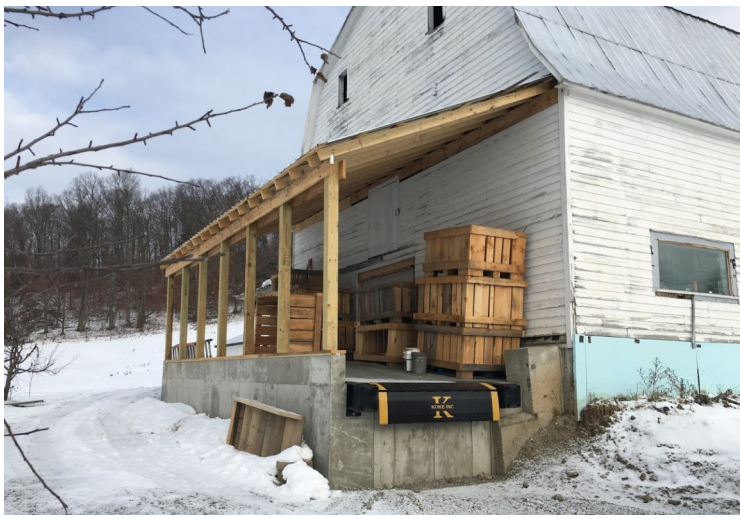
▲ The renovations included installing a covered loading dock, with a dock leveler. This enables easy wholesale transactions and adds additional outdoor covered storage.

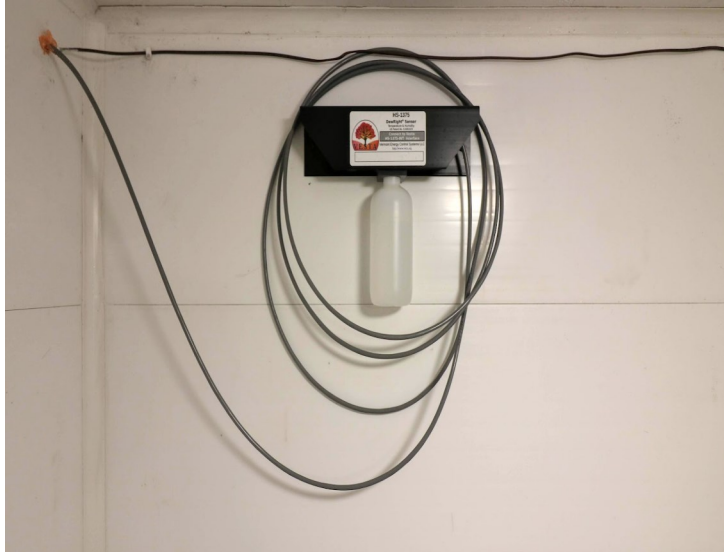
▲ The DewRight Humidity sensor accurately measures and reports the relative humidity to a computer which controls humidifiers to optimize storage conditions to ideal set points for storage crops.

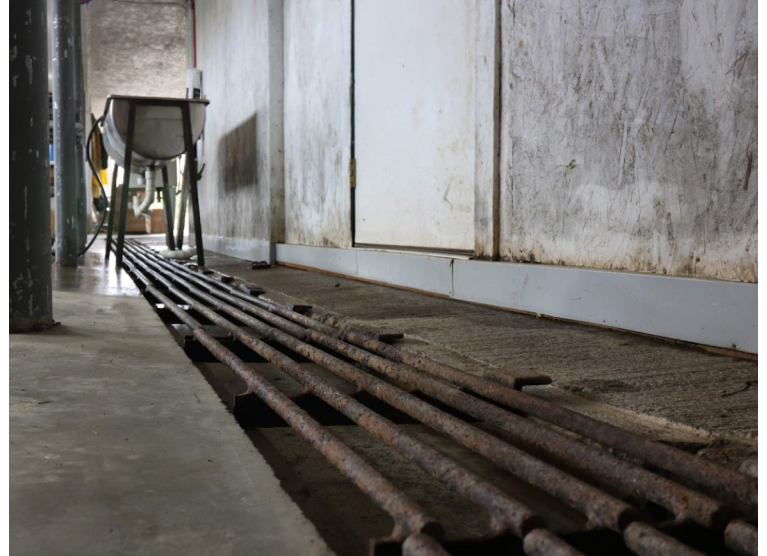
▲ Silas utilized the existing gutter of the dairy barn for wash water catchment. Some chiseling/grading and installation of a clean-out was needed to manage the sediment.

maintain was an important factor to reduce food safety risk. Cleaning out the sediment trap is a labor intense job that has to be done periodically when washing heavily loaded crops.

A “gutter” style trench drain and floors pitched to it. Using a 2% slope, water and debris easily find their way to the gutter which can be cleaned out on a routine basis. “I think that that’s actually the most important feature that we have here,” noted Silas pointing to the drain.
