Long-Term Monitoring of Tile Drainage in Cranberry Farms

Nickolas Alverson², Casey D. Kennedy¹, Peter Jeranyama³, Hilary Sandler³, Carolyn DeMoranville³, Frank Caruso³

1: USDA-ARS, casey.kennedy@ars.usda.gov, 2: Department of Environmental Conservation, UMass Amherst, 3: UMass Cranberry Station

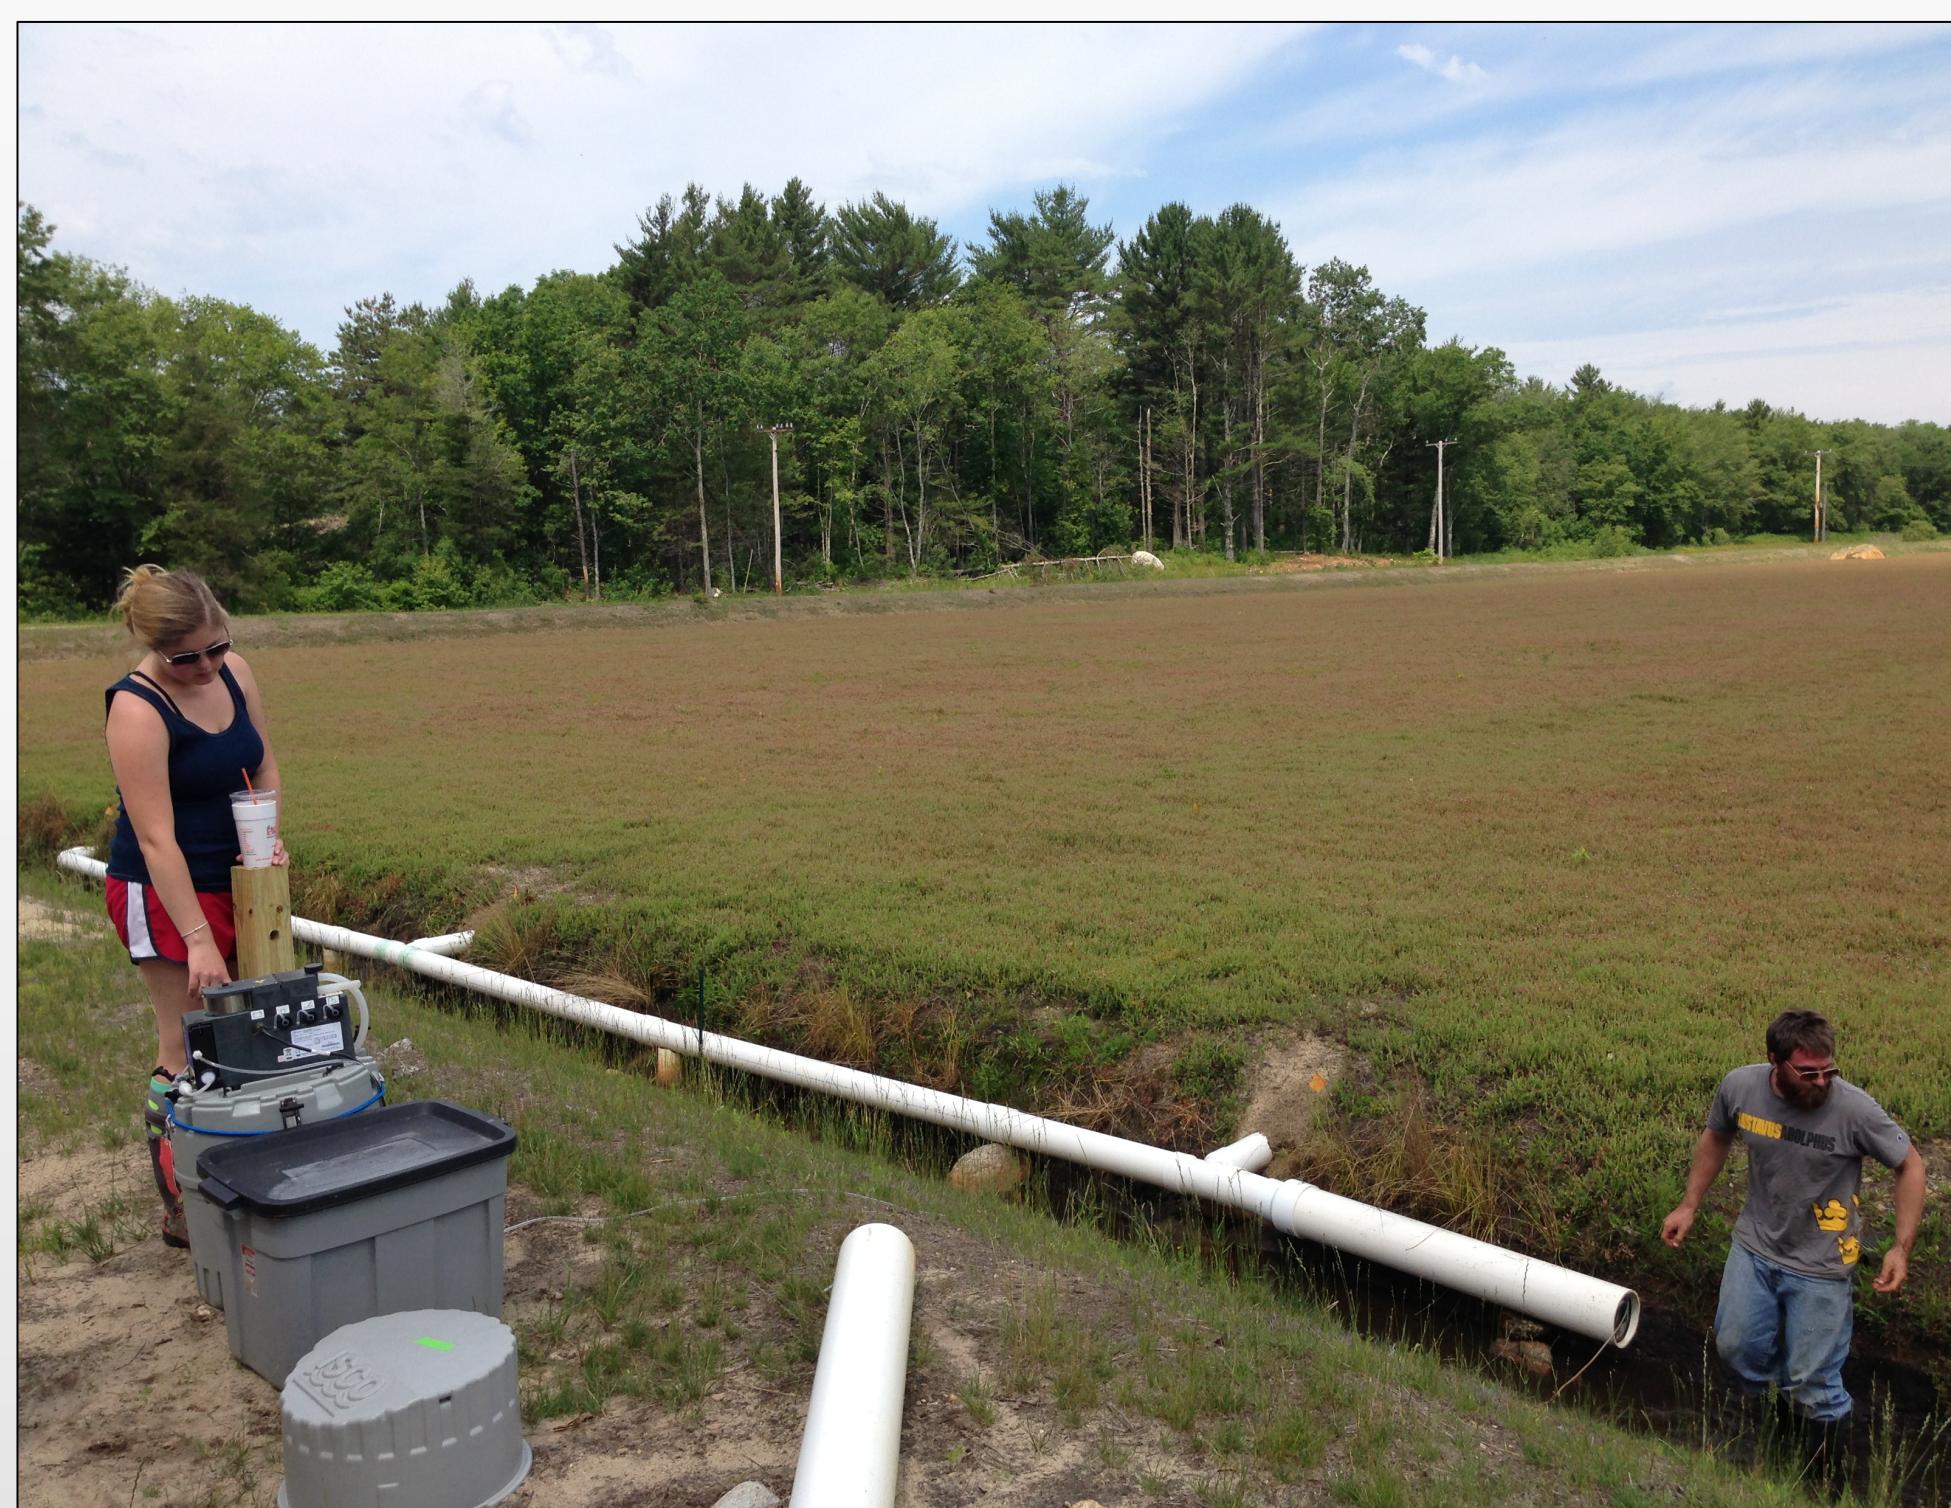
Three tile cluster on the south end (TD1).

- Groups of 3 and 4 tiles connected with PVC pipe.
- Continuous (15-min) volumetric discharge measured at the outlet of each of the 4 tile cluster groups (TD1-TD4).
- Compound weirs and area-velocity meters used to measure discharge.
- Daily composite (6-hr) water samples collected at each tile outlet (4 total) for analysis of nutrients (N and P).

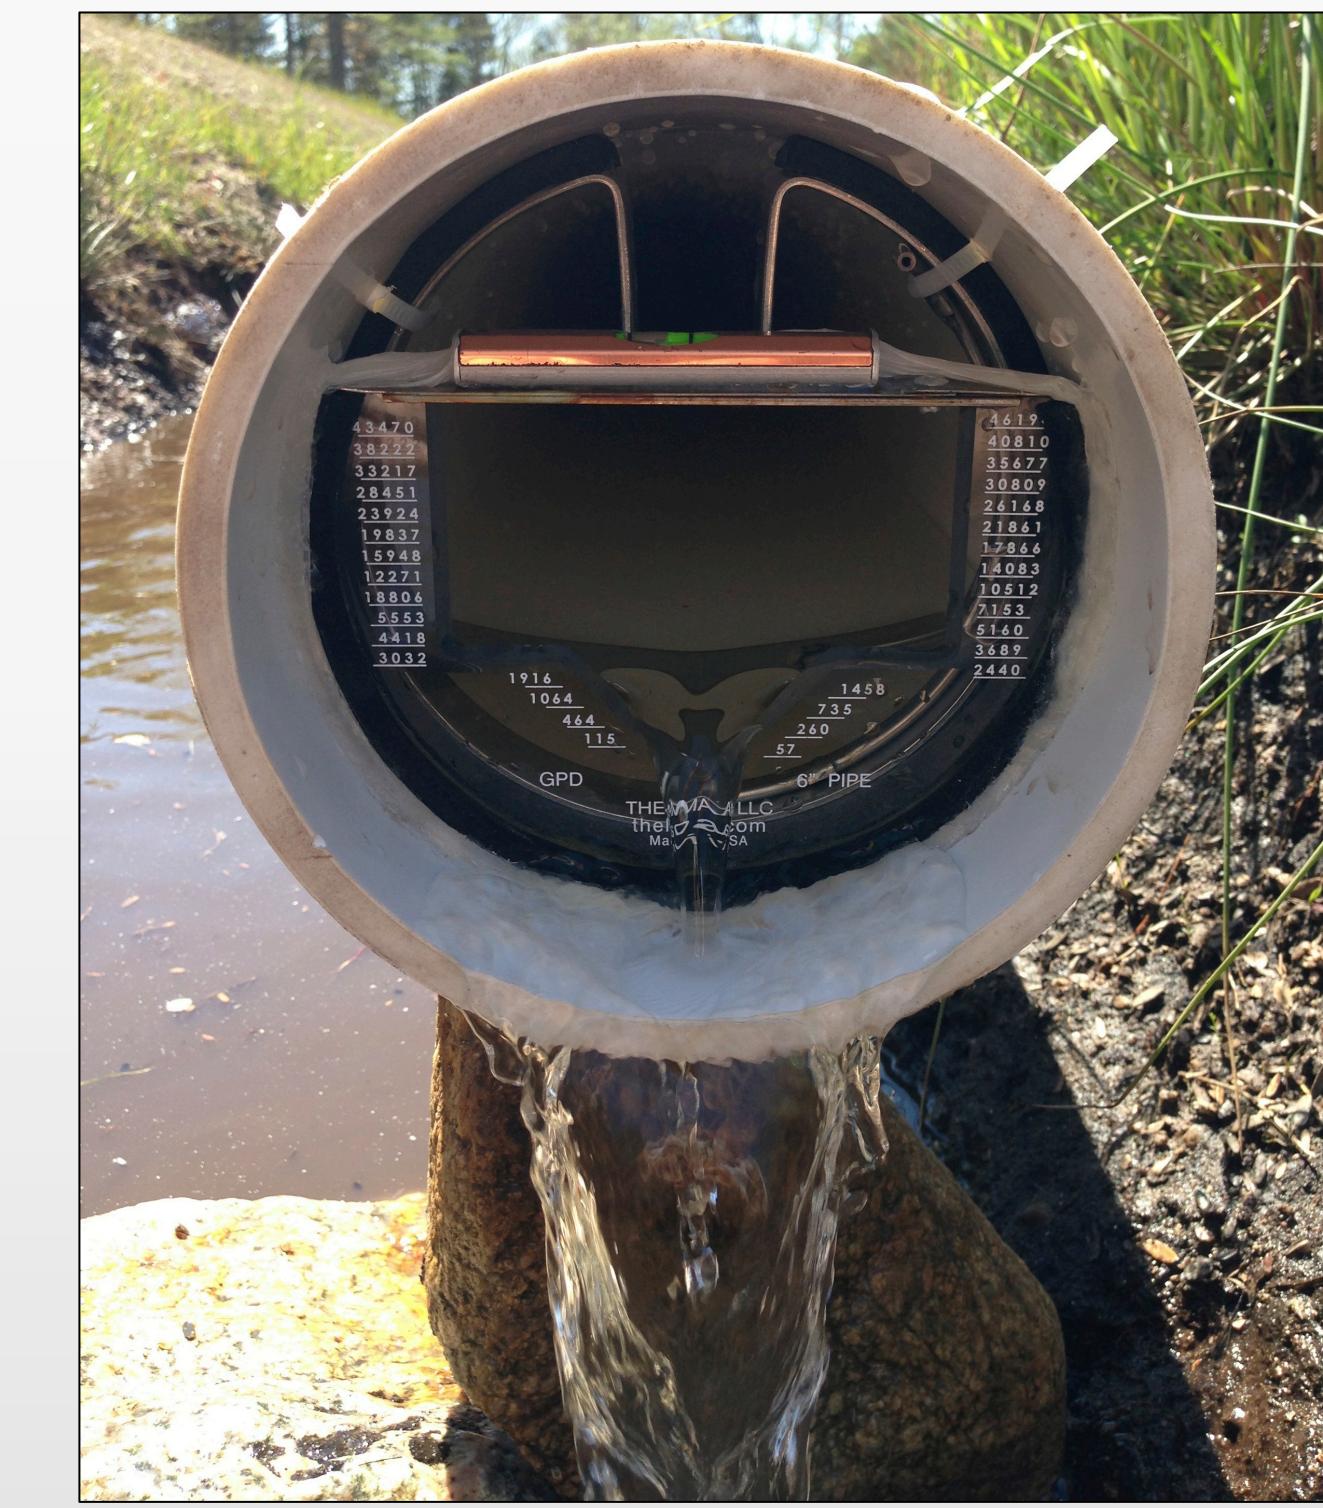
Discharge measurement at TD1.

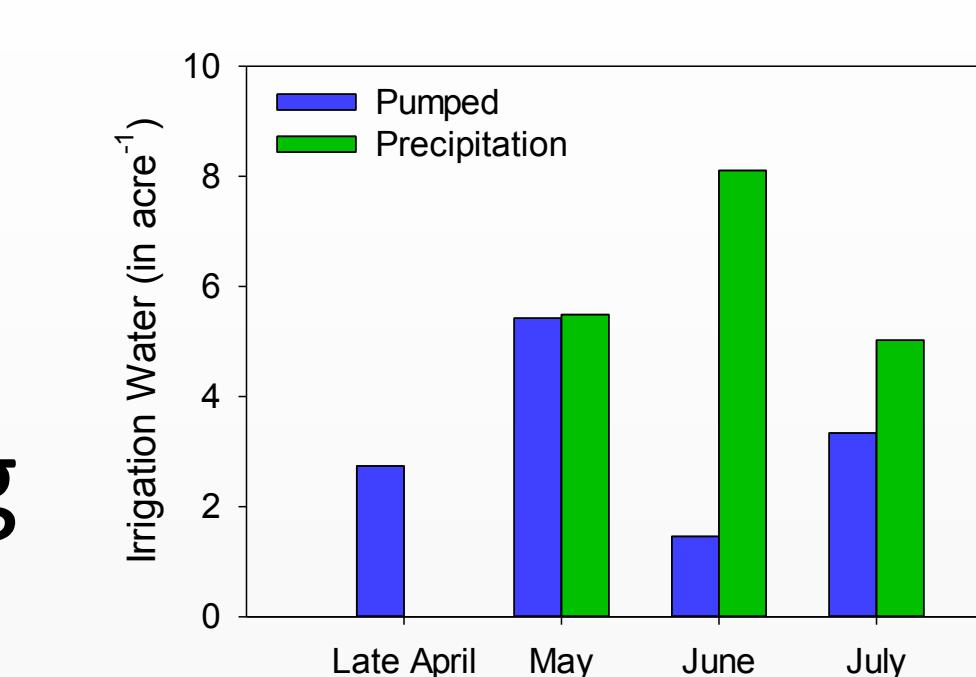
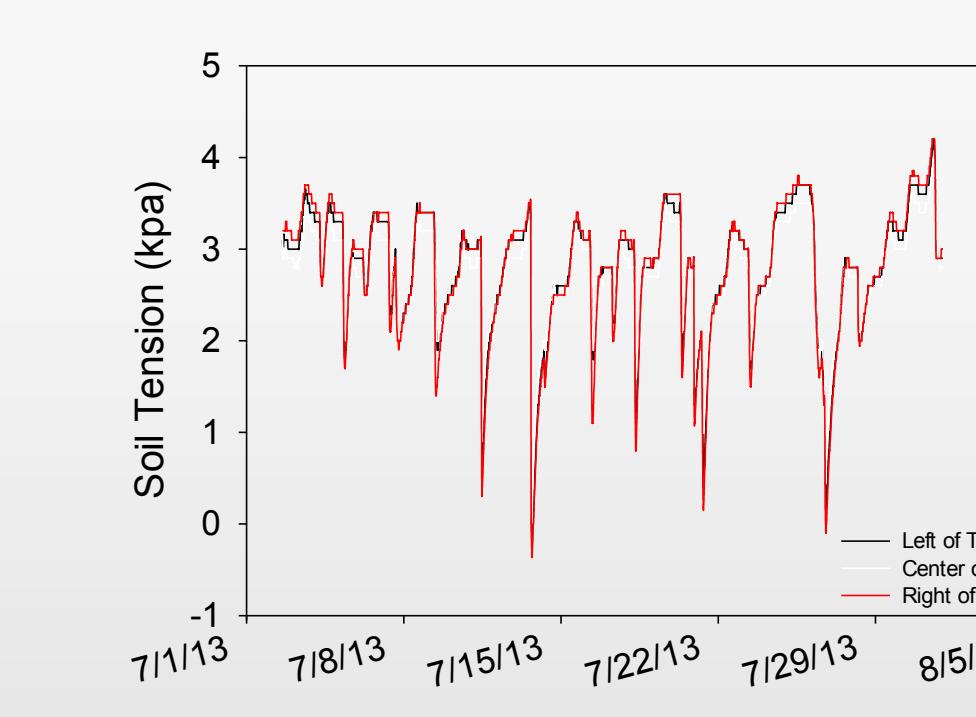
- Irrigation water: Propeller flow meter installed on irrigation pump.
- Off-site runoff: Weir installed on flume draining bed.
- Soil tension: Soil tensiometers installed in bed center.
- Groundwater level: Shallow well and pressure transducer installed in bed center.
- Water sampling: Daily to weekly sampling of water inputs and outputs.

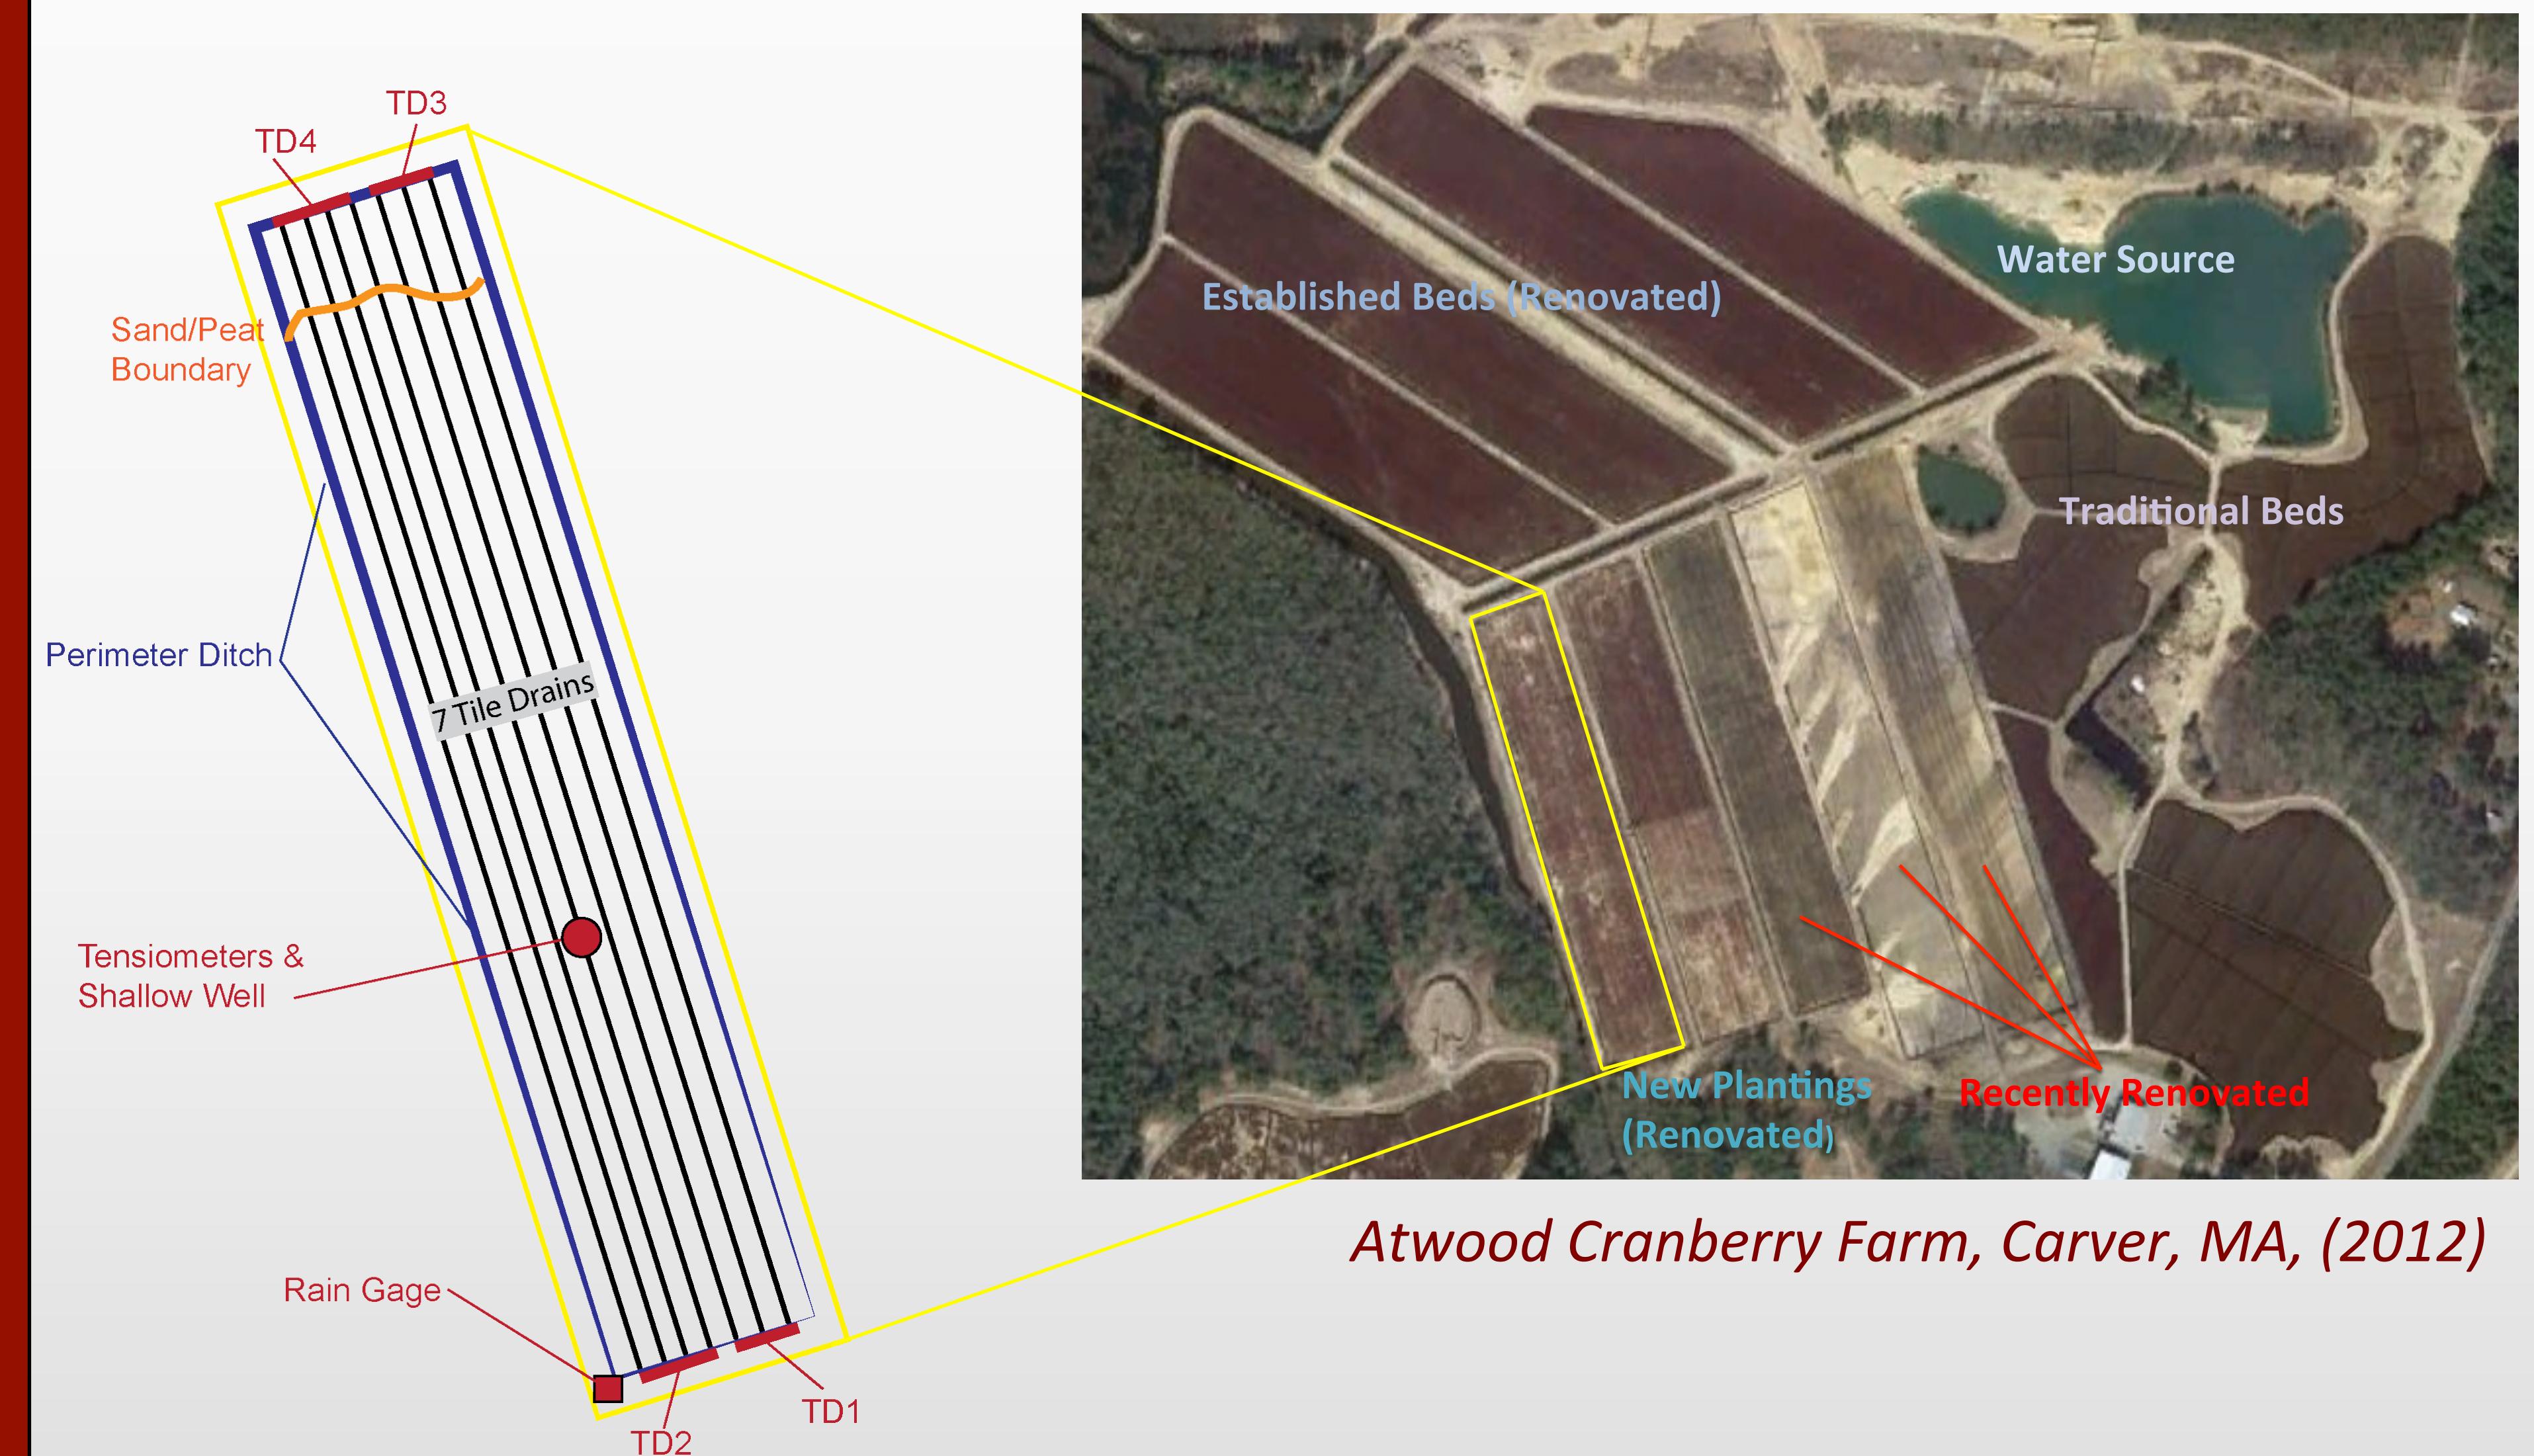
- Site is a 5-acre cranberry bed, part of an 88 acre farm in Carver, MA.
- Renovated (2010), including installation of tile drainage, squaring at ends (peat absent in north section), and new plantings (Stevens).
- Tile drainage consists of 7 lengthwise tiles (not socked), spaced at 20 ft and installed to a depth of 1 ft.

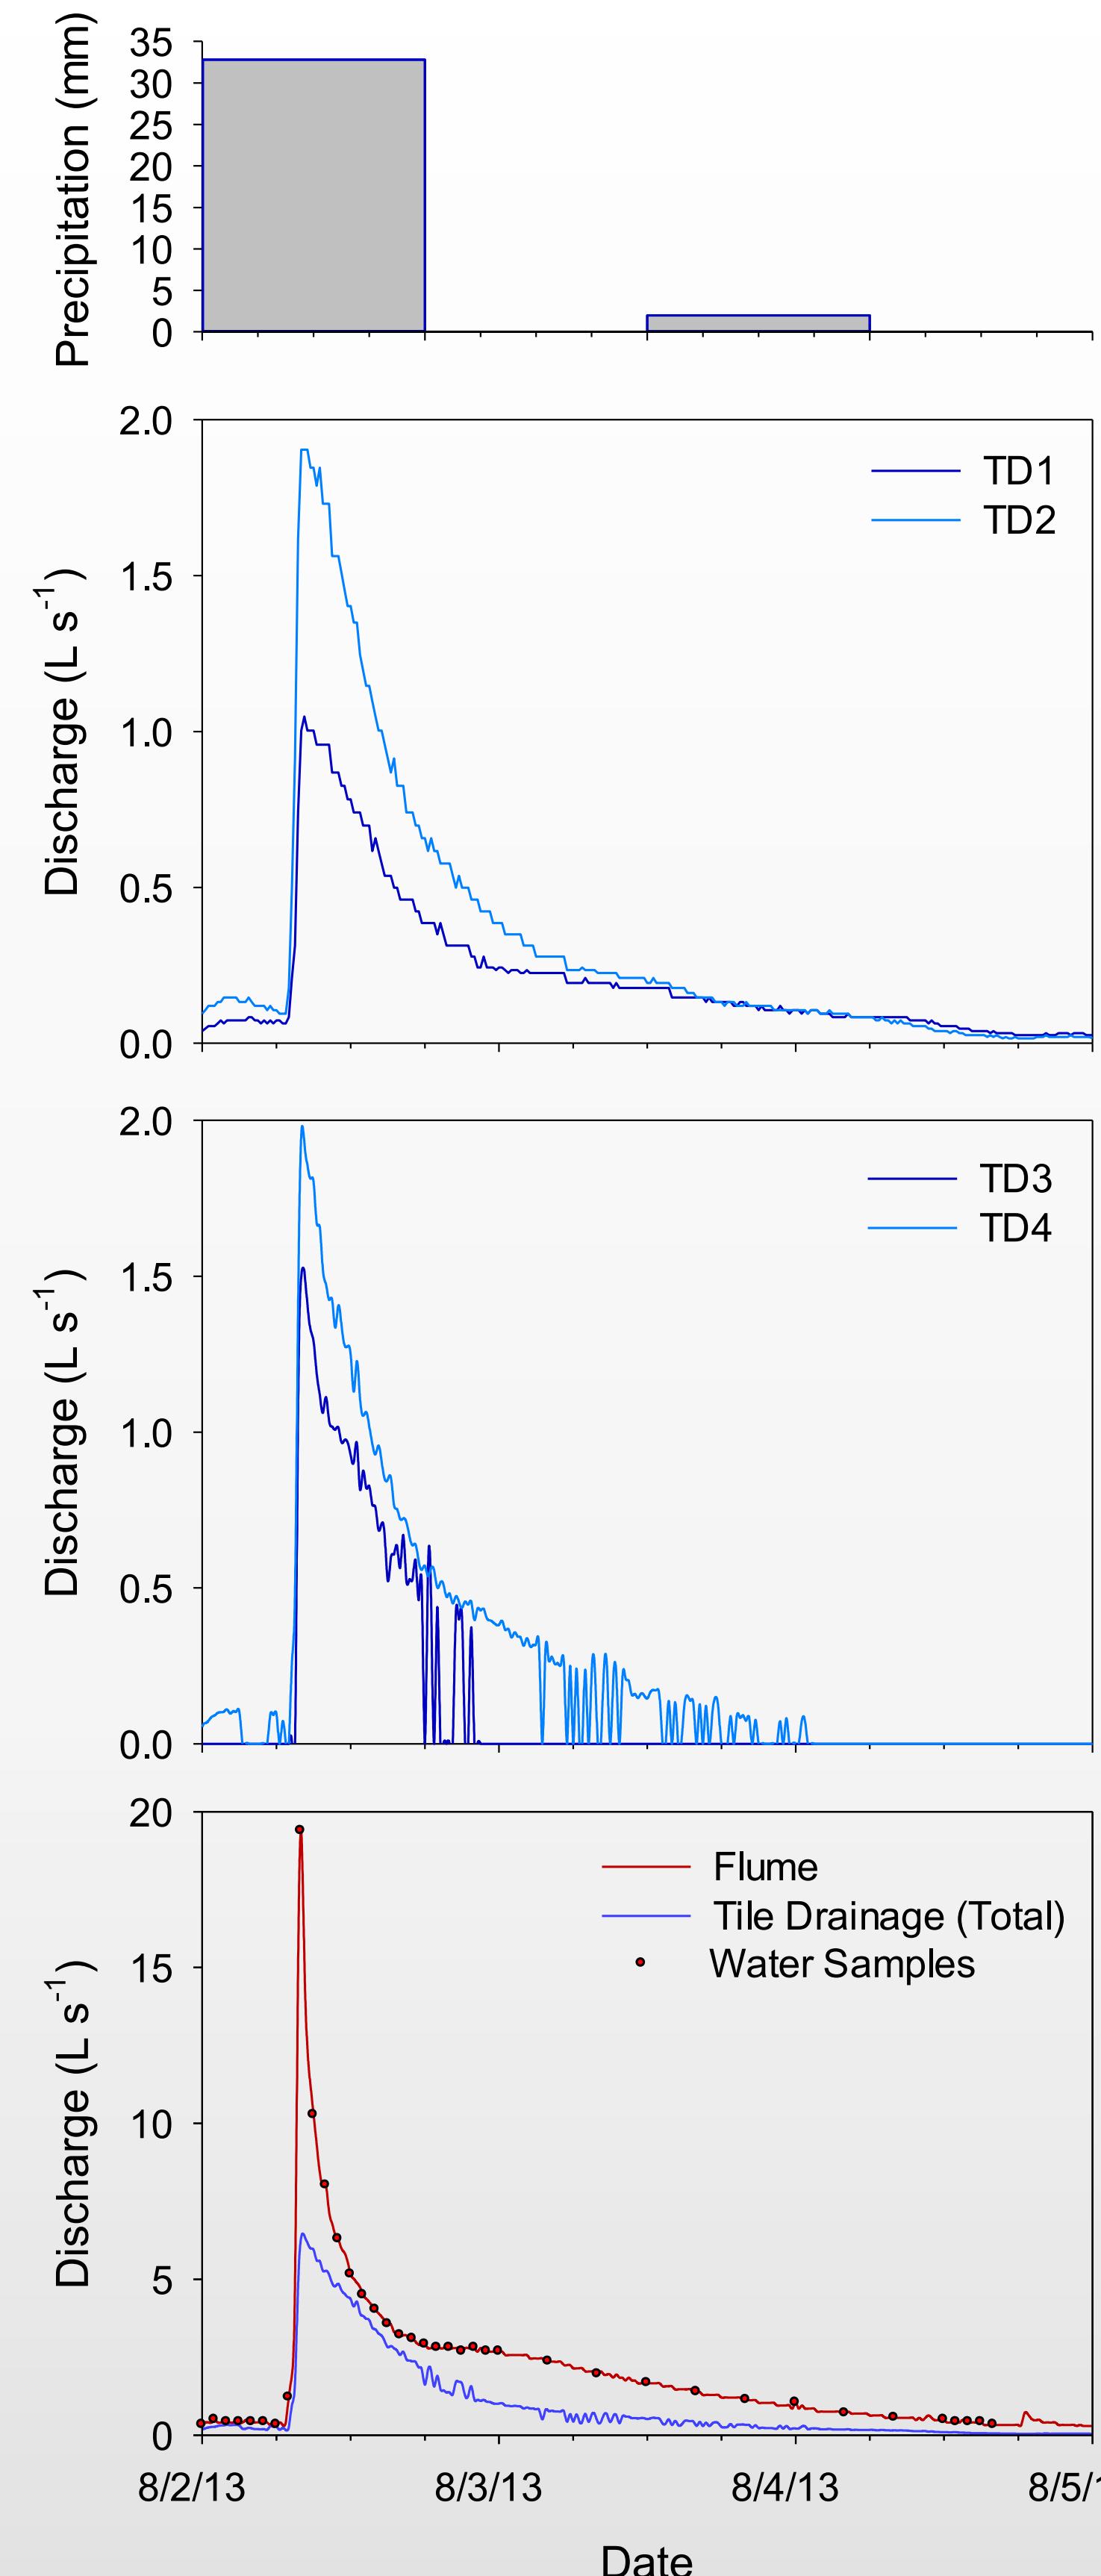
- Tile and flume discharge monitored following a 3.2 cm (1.25 in) rain event.
- Similar hydrograph rising limb among tile and flume sites; more prolonged falling limb in tile sites.
- Discharge from TD3 and TD4 ceased at 18:00 on 8/2/13, coinciding with submergence of the tiles.
- Integrated water inputs lower for the 3-tile groups (57 m^3 , TD1; 35 m^3 , TD3) than for those including 4 tiles (86 m^3 , TD2; 67 m^3 , TD4).
- Total discharge from tiles equaled 244 m^3 , about half the discharge exiting the flume (516 m^3), and 1/3 of the rain deposited on the cranberry bed (745 m^3).
- Water samples will be analyzed to quantify N and P loss from the bed and attenuation in ditches
