Quivira Coalition - WSARE annual report 2021

## Site 1 Before & After Hughes Ranch

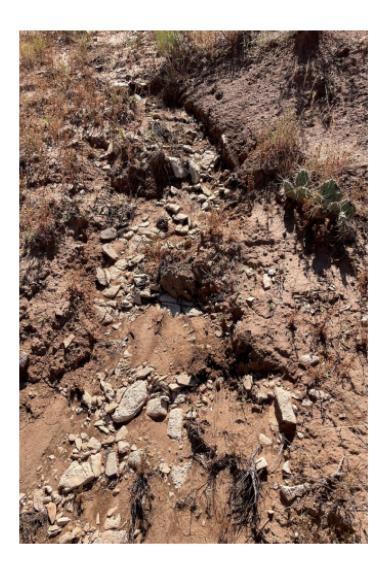
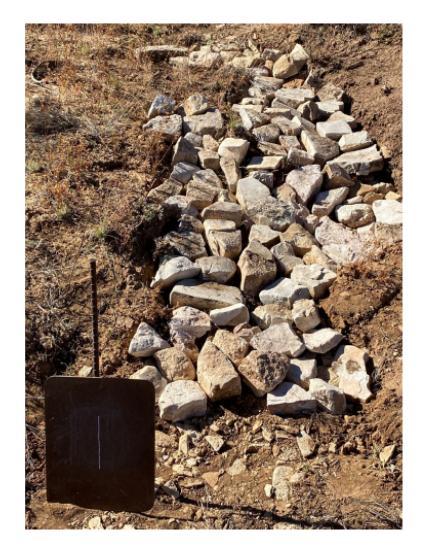
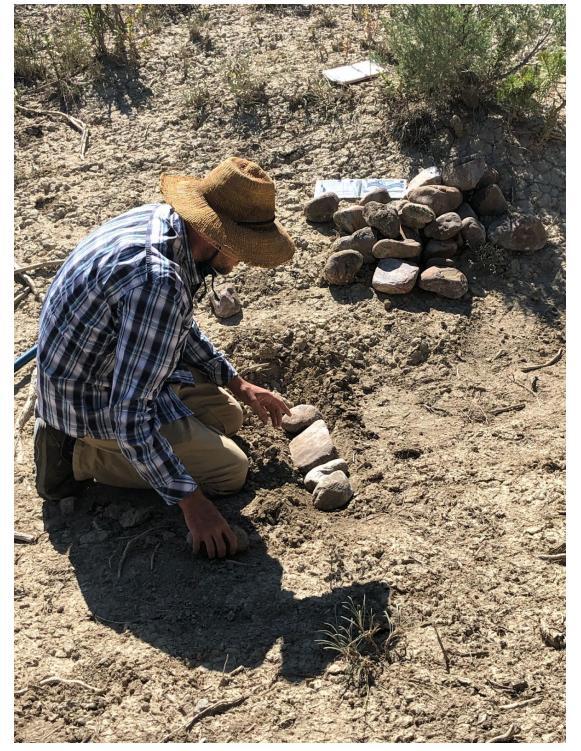
Figure 1. Top: Example of head cut and treated site on Hughes ranch. Bottom, example of building rock run-down from the bottom (splash guard) up at Esquibel ranch.

The ranchers marked 18-30 sites that were actively eroding. They then collected rock material onsite, or, in one case, purchased stone from a local landscaping company. We held two workshops with expert guidance (Aaron Kaufman, Esquibel Ranch; Mori Hensley, Sol Ranch) leading groups of volunteers to learn how to build one rock dams to armor the site of active erosion to reduce further degradation (See Figure X). For sites without the expert guidance, we provided guidance and publications such as the erosion control field guide (<u>https://quiviracoalition.org/erosion-control-fg/</u>).

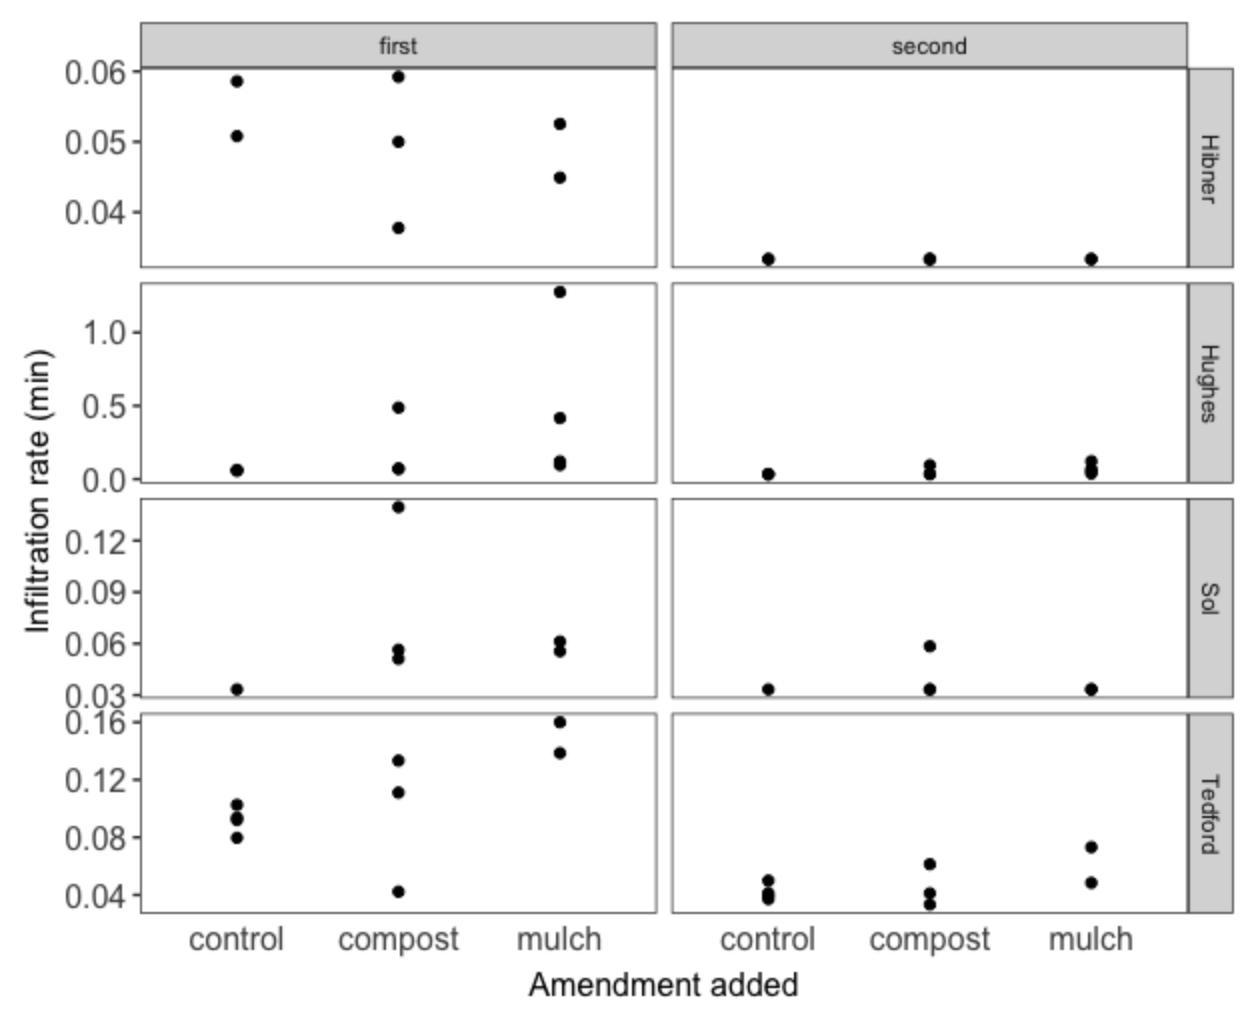
Figure 2. Baseline infiltration rate data for the first and second inch of water by amendment and site. Note. Esquibel Ranch has not yet been recorded due to snow accumulation during field work.

*Infiltration Rate.* Infiltration rate was collected from the center of each plot in an interspace area free of perennial vegetation. We used the single ring infiltrometer method (NRCS) and timed both the first and second inch (Figure 2).

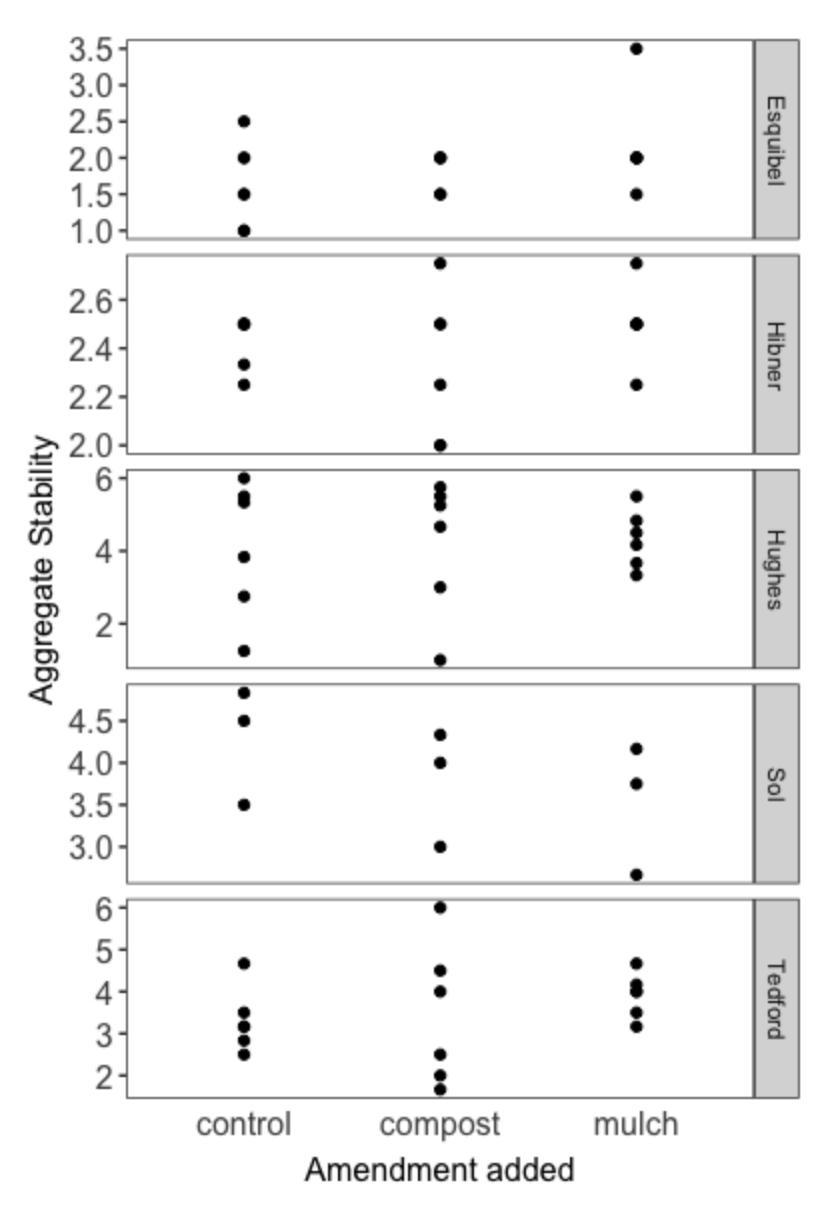
Figure 3. Baseline aggregate stability data (unitless rank) for five ranches by amendment and site. Note that y axis values differ by ranch.

*Aggregate Stability.* We assess surface aggregate stability using standard methods and the soil stability kit (Herrick et al. 2017) for 4-6 aggregates per plot (Figure 3). Aggregates were collected haphazardly from interspace locations throughout the plot.

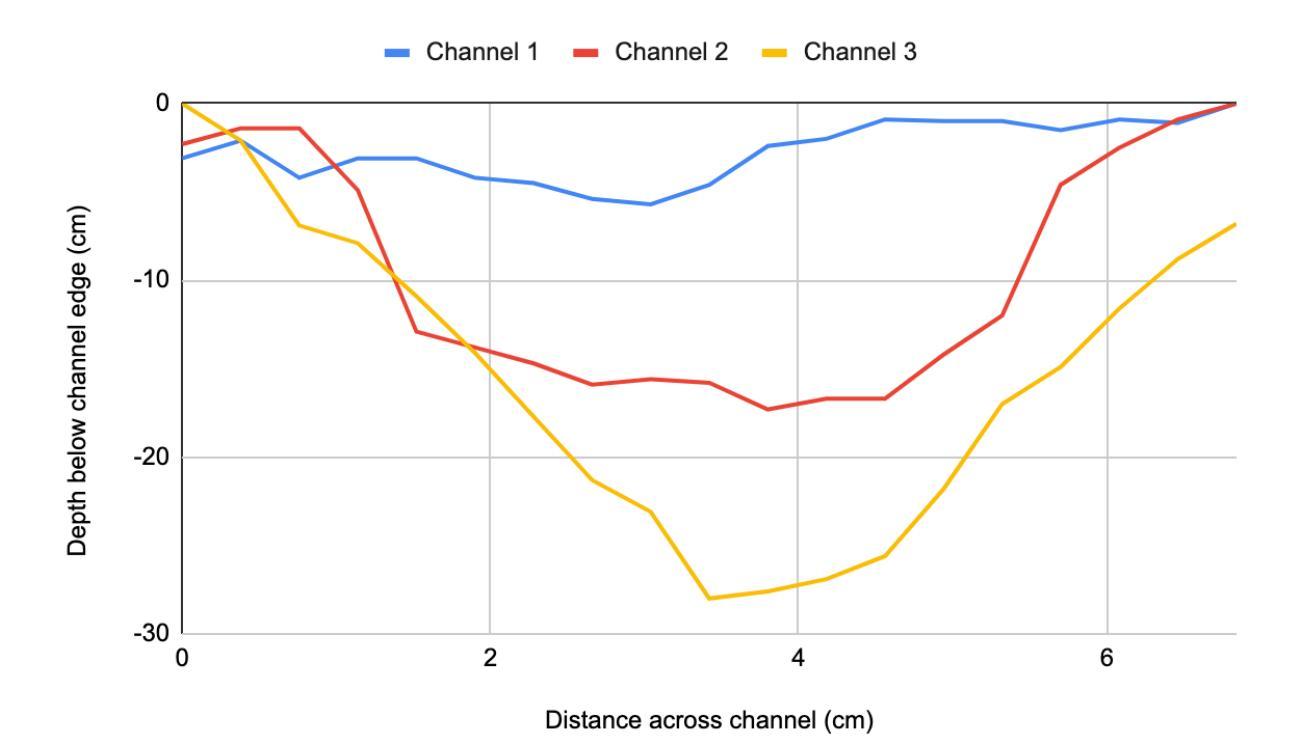
Figure 4. Example of three channel cross sections from Tedford Ranch with depth (cm) on y axis and distance across channel (cm) perpendicularly on the x axis.

*Erosion/Accretion.* If the channel below the erosion control structure was shallow (<50cm) and narrow (<1m) enough, we added wooden stakes to either side and used a level to ensure that they were completely level. We then used a contour measuring device (Kornecki et al. 2008) to record the cross cross sectional area of each channel with 19 points (Figure 4).

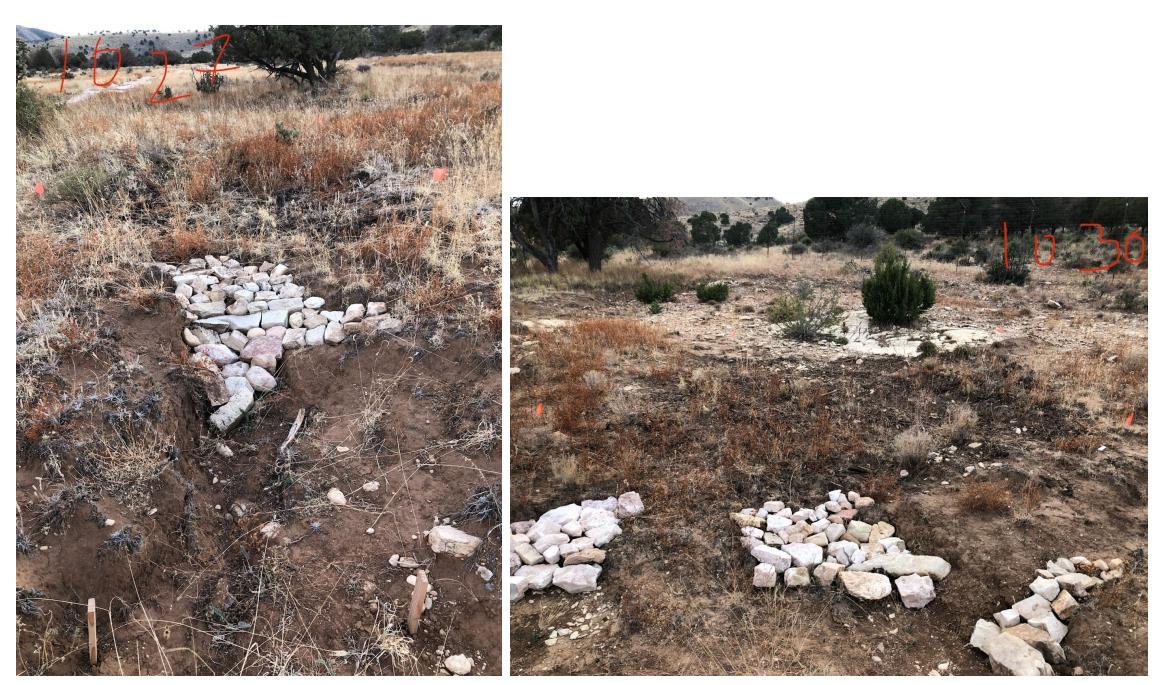
Figure 5. Example of two completed plots from Hughes Ranch, December 2021.

*Photos.* We took photos looking upslope from the rock structure to the plot for each plot after completing treatments (See Figure 5).
