## A case study for water reuse in nursery production

### Introduction to the study setup

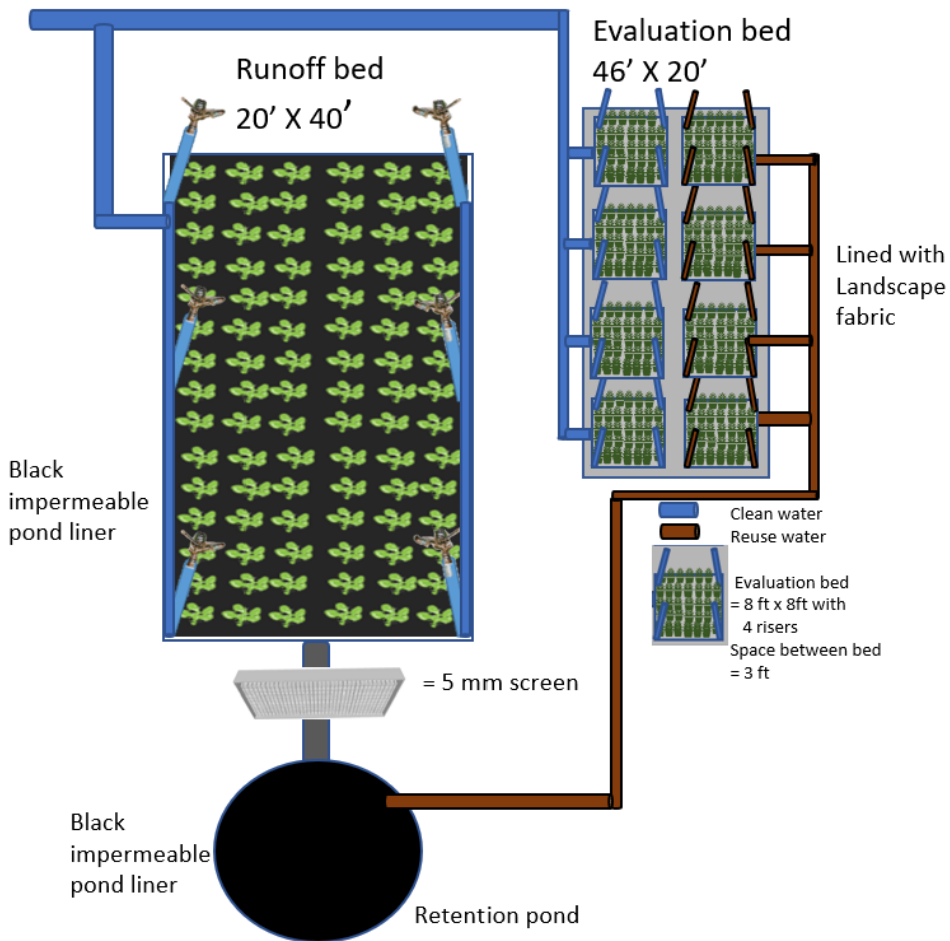
Figure 1: Sketch of the study site (not to scale).

In 2023, we conducted a grower-based research trial at Progressive Plants, a commercial nursery in Copperton, UT 84006. The study setup (Fig 1.a and b.) was completed on July 20, 2024, and treatment began on August 1. The study aimed to evaluate the effects of reused water on plant growth and visual quality by comparing plants grown using municipal water with reused runoff water containing agrochemical residues. To generate runoff water, we constructed a runoff bed that was 6 x 12 meters (20x40ft). The runoff bed was a simulation of a nursery production. Our grower treated nursery bed as he would treat his other production site by applying same fertilizer and pesticides that he applied to his other production sites.

The evaluation bed consisted of 8 blocks, each measuring 2.4 x 2.4 meters. Each four blocks received either municipal water or reused water. Reused water was sourced from water collected in the retention pond and pumped from irrigate plants as overhead irrigation. This setup allowed for the assessment of any potential impact that reused water

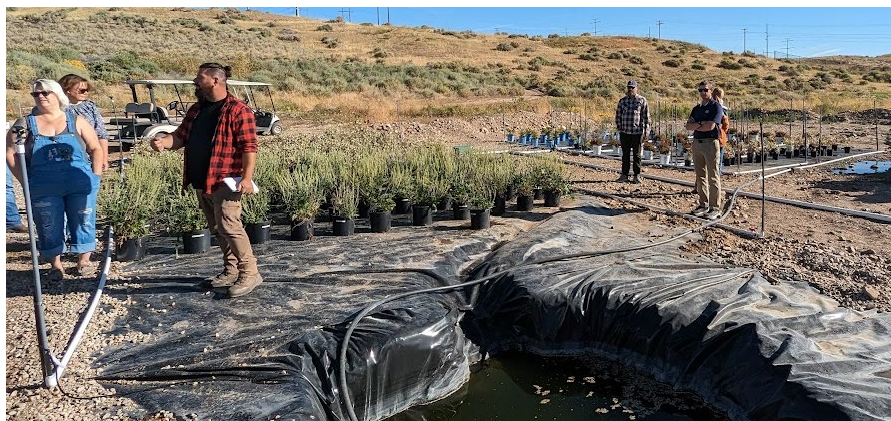
Figure 2: Real image of the study site

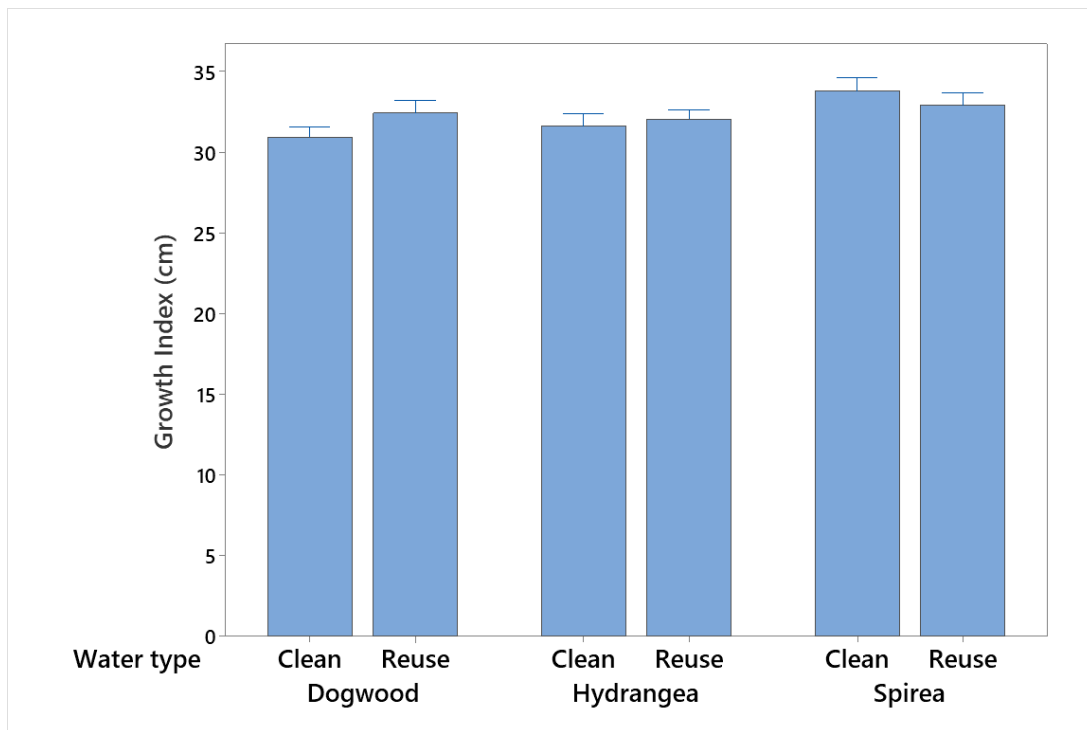
Figure 3: Comparison of growth index, which is calculated as the average of height, and two perpendicular widths of the plant, between clean and reused water for three different plant taxa. There was not significant difference between the values for clean and reused water on any of these taxa at  $p < 0.05$ .

At the end of the study, plants were evaluated for growth index and visual rating. The results indicated no significant differences between treatments, except for *Hydrangea*, which showed a higher visual index when irrigated with reused water compared to municipal water. This suggests that reused water will not have any adverse effects when irrigating container plants i.e, dogwood, hydrangea and spirea.

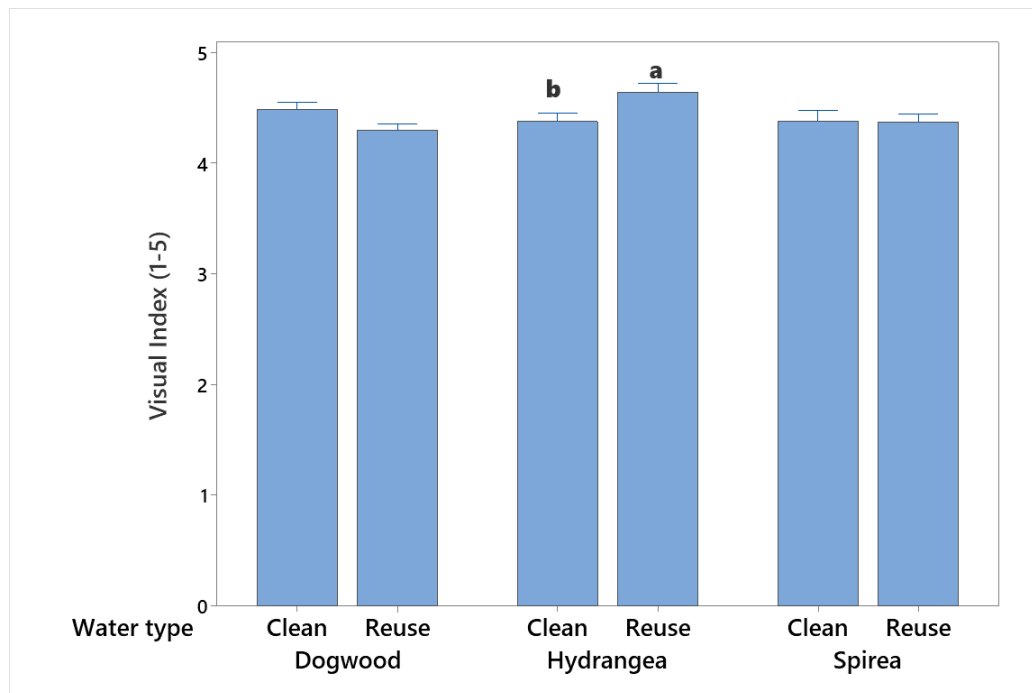
Figure 4: Figure 3: Comparison of visual quality on the range of 0 to 5, where 0 being a dead plant and 5 being a perfect plant, between clean and reused water for three different plant taxa. There was not significant difference between the values for clean and reused water on dogwood and spirea at  $p < 0.05$ , however for hydrangea reused water had better visual quality compared to clean water.

The study demonstrated that the use of reused water in irrigation did not negatively impact plant growth or visual quality of container grown plants. The exception was Hydrangea, which exhibited an improved visual index with reused water. These findings suggest that runoff water can be a viable irrigation source without compromising plant health and aesthetics. This research was conducted at growers' site and by the growers with minimal data collection hence serves a case study rather than a robust research. Further research may be needed to assess the long-term effects of reused water on plant performance.
